PRELIMINARY ASSESSMENT

Columbus Auto Parts**DATE:** 15, May 1994**OHIO ID #:** 125-1461**USEPA #:** OHD004286381

Address: 575 Hudson Street
Columbus, Ohio 43216
Franklin County

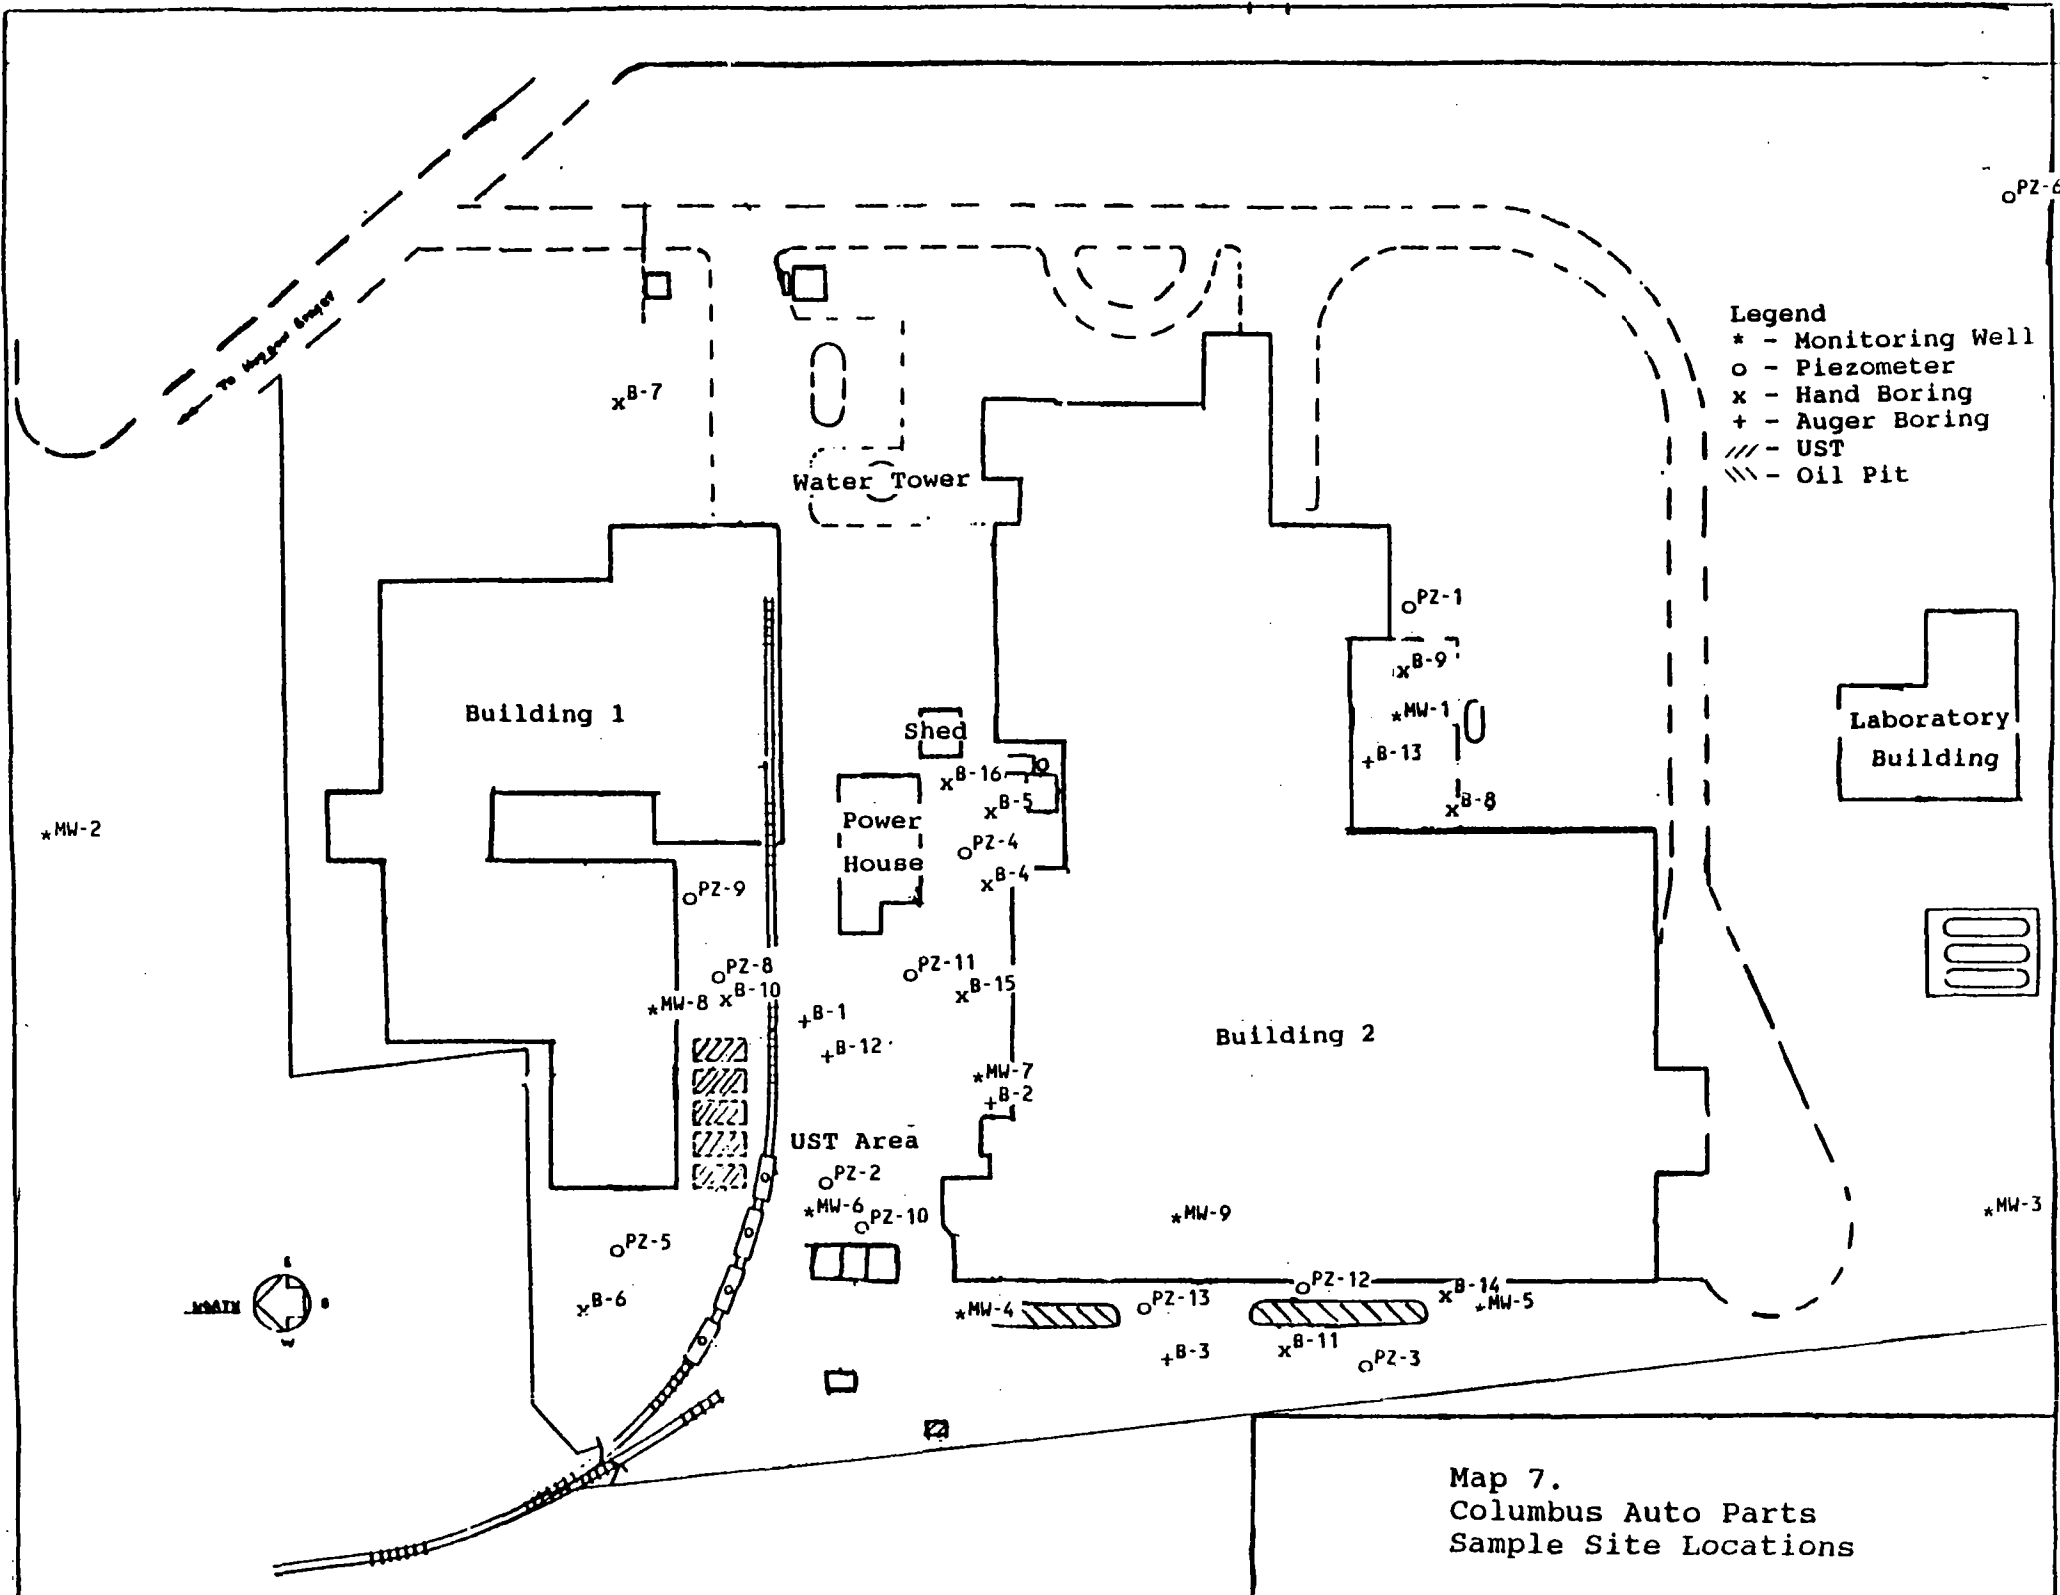
Map 7.
Columbus Auto Parts
Sample Site Locations

As a result of the Assessment, three principal areas of oil, volatile organic compound (VOC) and polynuclear aromatic hydrocarbon (PAH) contamination were determined: the Oil Pit area, the Loading Dock and the areas between and to the west of Buildings 1 and 2 (including the Shed and underground storage tank (UST) area). All of the facility's buildings contained asbestos. VOC, PAH and oil contamination was found in the soil throughout the areas demarcated on Map 8. The only identified source of polychlorinated biphenyl (PCB) contamination was found in the structure known as the Shed. The sample collected from the Shed yielded 180 ppm of PCBs, but no VOCs or SVOCs were tested for at that site.
